② LAKE SUSQUEHANNA DAM

NDS ID NO. PA-00818

PHASE I INSPECTION REPORT
NATIONAL DAM INSPECTION PROGRAM

AUGUST 1978

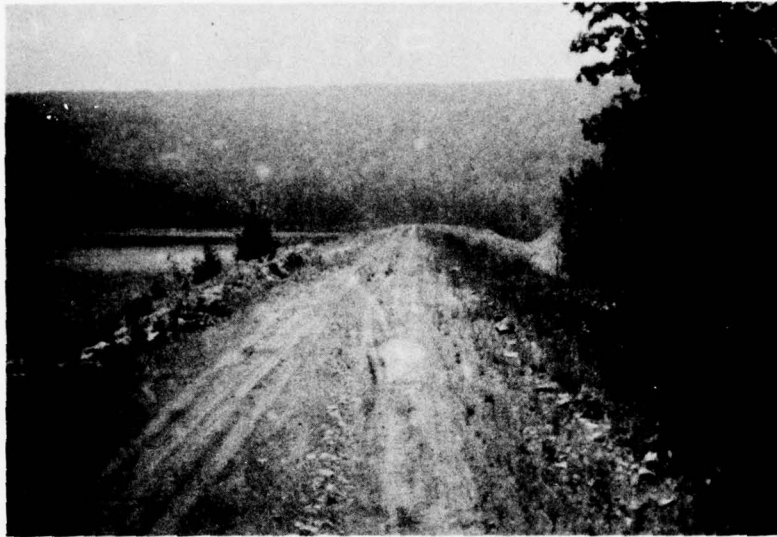
A. Embankment — View from Right Abutment.

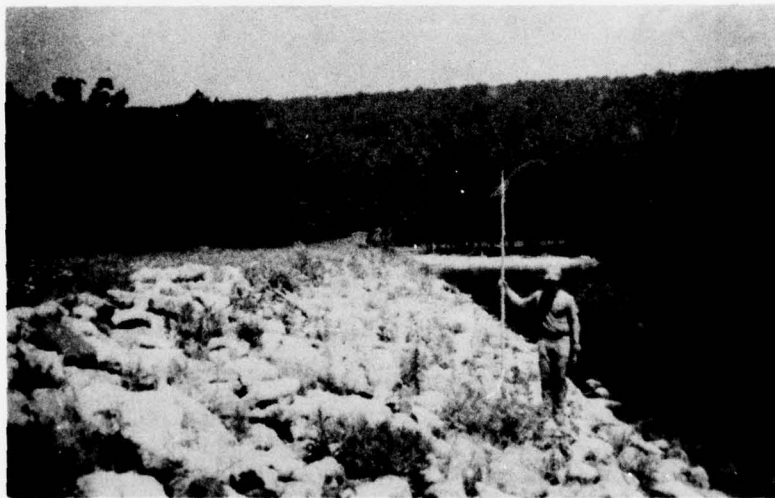
B. Riprap on Upstream Slope
Near Center of Embankment.

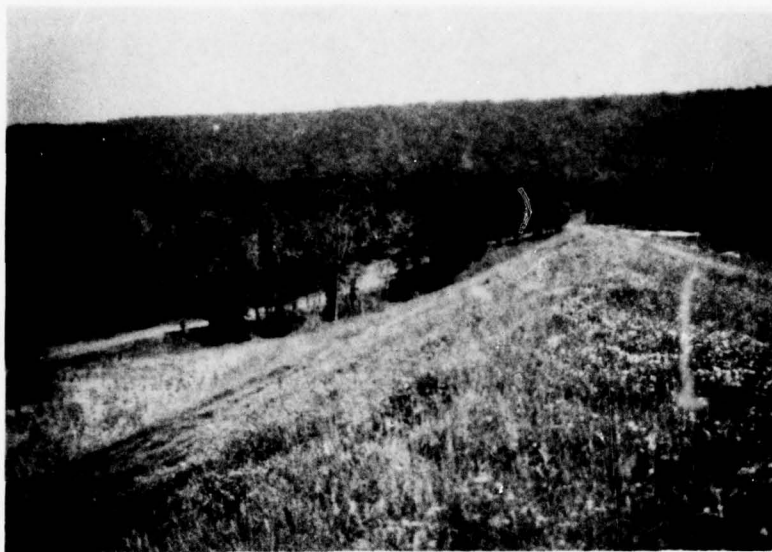
(4) Except for a few small areas, the downstream slope of the embankment was covered with crownvetch, grass, and clover ranging from 12 inches to 30 inches high (Photograph C). Those areas not yet covered with vegetation will soon be covered. Some minor sloughing and gullying were observed, but it appeared that it had occurred before vegetation had become fully established. A typical sloughed area is shown on Photograph D. Anti-erosion boards that were installed about mid-height on the downstream slope in conjunction with repair of erosion gullies in 1976 are still in place (Photograph D).

C. Downstream Slope of Embankment —
View from Left Abutment.

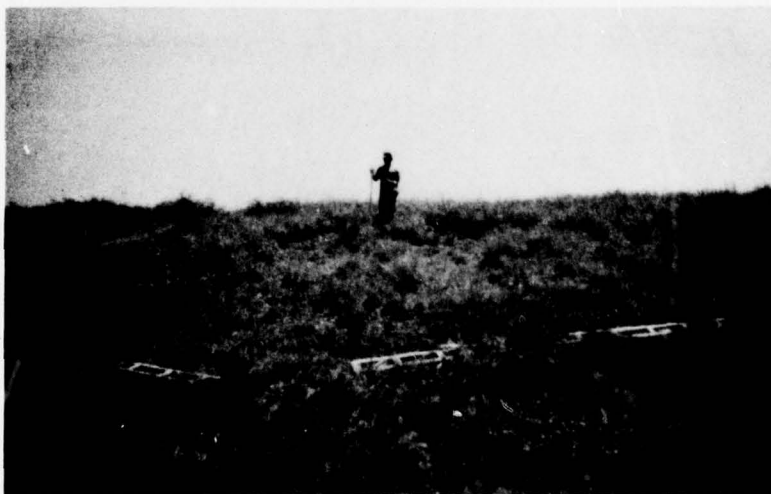
(4) The sloughing and erosion that was observed is minor and repairs to the embankment are not warranted. The downstream slope of the embankment appears to have been stabilized by the vegetal cover that was established in 1976, and it is unlikely that erosion and sloughing will occur in the future.

D. Sloughed Area on Downstream Slope
Near Spillway.

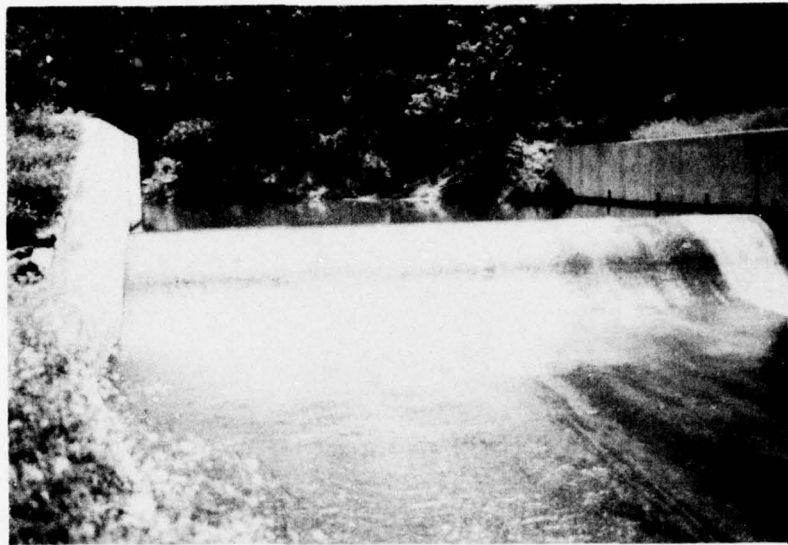
(1) Spillway. No deficiencies were noted for the concrete chute spillway. The concrete was in excellent condition and all joints were sealed (Photographs E and F). However, the spillway discharge channel was apparently not constructed in accordance with the plans. The riprap in the discharge channel extends about 80 feet downstream on a 1V an 4H slope (Photograph H), whereas the plans show riprap for a distance of 125 feet. In addition, the riprap was not grouted in place as shown on the plans. The placement of the riprap was not uniform and occasional gaps were visible. The size of the stone ranges from about 12-inch stone to derrick size stone. It did not appear that a specific gradation had been used. At the end of the riprap, the channel makes a sharp bend to the right. This unlined outlet channel then runs approximately parallel to the toe of the dam until it reaches the center of the valley, where it then curves to the left and follows the natural stream channel. A profile along the outlet channel showed that the

E. Spillway Approach Channel and Spillway Crest.

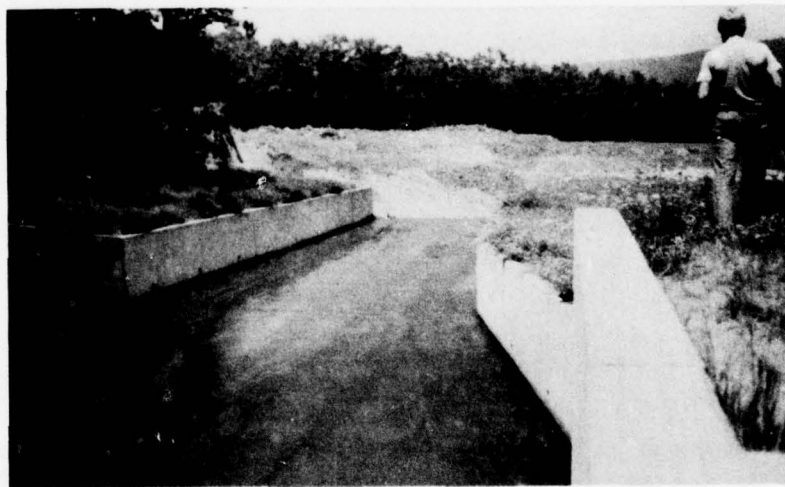
F. Concrete Spillway Chute.

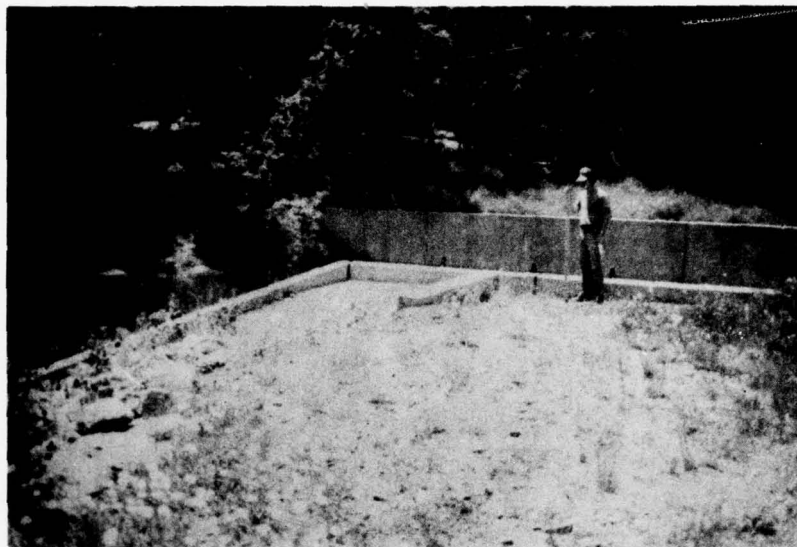
(5) If the low area of the top of embankment were brought up to grade, which would be a relatively minor maintenance task, the spillway capacity would be increased to 2,740 cfs. This would permit the accommodation of a flood with a peak inflow of 3,330 cfs, or 66 percent of the Lake Susquehanna PMF peak flow. The spillway capacity of Lake Susquehanna Dam would still be rated as inadequate.

G. Low Area on Embankment at Spillway.

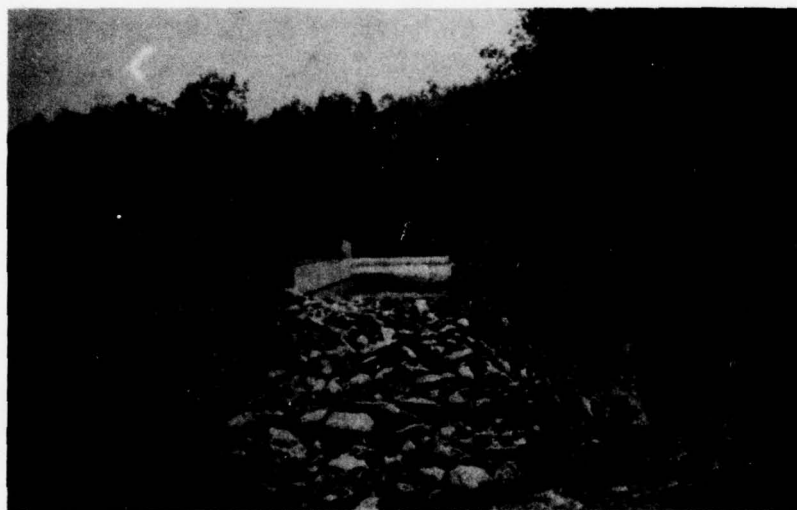
(1) Spillway. The reasons for the departures from design for the riprapped portion of the spillway discharge channel are not known. The nature of the departures are such that progressive erosion of the steep slope might occur during large spillway discharges. However, the area is located 120 feet downstream from the dam, and it is more likely that damage to the spillway chute would occur than damage to the embankment. With the exception of obvious deficiencies such as gaps and some stone that is too small, the overall adequacy of the extent and gradation of the riprap cannot be determined without additional study. As shown on Plate 5, the grade of the unlined portion of the outlet channel is lower than the design grade. This change was apparently made to accomodate the grade requirements imposed by the outlet works. However, this change has resulted in a deeper and steeper channel. Consequently, additional study is also necessary to determine if the existing channel is stable under high discharges.

H. Concrete Chute Spillway and
Spillway Discharge Channel.

(2) Fill gaps in riprap in spillway discharge channel with derrick stone. Perform additional study to determine the adequacy of the gradation and extent of riprap in the spillway discharge channel and outlet channel, and make any improvements that are found to be necessary.

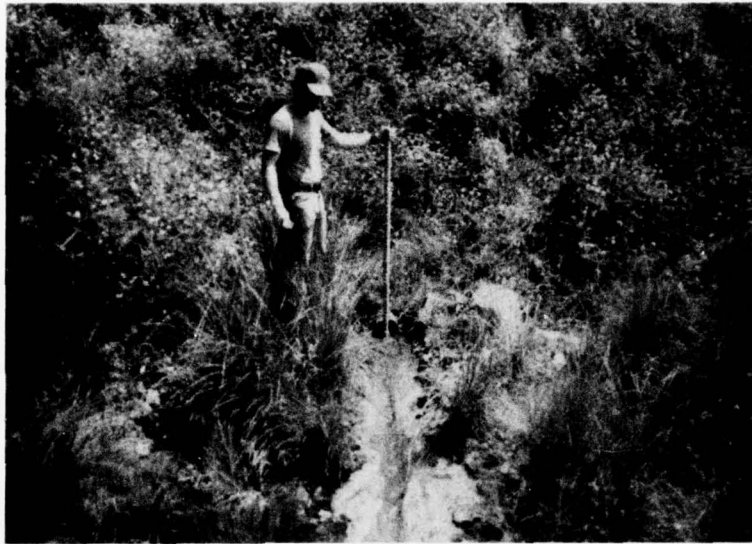
(6) The flow from the toe drain outlet that is located about 400 feet from the right abutment is expected because of the geologic conditions described above. The flow was clear, and the outflow appears to be satisfactorily controlled. The lack of significant flow from the outlets located in the outlet works outlet structure is also expected because the foundation is primarily a sandy clay. However, the accumulation of sandy clay along the length of the right outlet and the accumulation of sand and fine gravels in front of both outlets is of interest. Two explanations are possible. Either some migration of fine materials and filter materials has occurred, or the material has been sucked from the reservoir bottom during the course of operation of the slide gate. During the gate operation for this inspection, it was observed that the water level in the outlet structure rose to such an extent that some flow occurred from the outlet structure into the toe drain outlets. It was also observed that the water from the conduit was muddy. In either case, no great concern is warranted at the present time.

J. 6-Inch Toe Drain Outlet
400 Feet from Right Abutment.

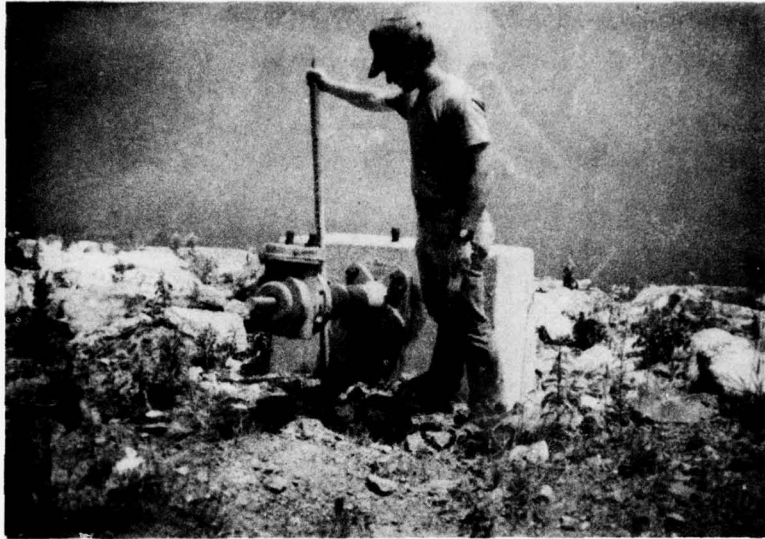
(2) Outlet Works. The gate stand at the top of the embankment was in good condition (Photograph L). The 36-inch RCP outlet conduit and the outlet structure were in good condition except for some fine cracking that extended outward from an expansion joint where the conduit enters the outlet structure. About 3 cubic yards of mud, sand, and fine gravel were in the outlet structure. The intake structure and the slide gate were submerged and could not be inspected. However, the gate was opened easily to about 1/3 full opening (Photograph M). The Owner said that the gate is partially opened every six months, and, at the same time, the oil level in the stem casing is checked to ensure that it is full. After operating the gate, it sealed tightly with no significant leakage. The discharge channel from the outlet works is riprapped with 12-inch stone from the outlet structure to where it joins the spillway outlet channel. No evidence of erosion was visible.

L. Gate Stand on Top of Dam.

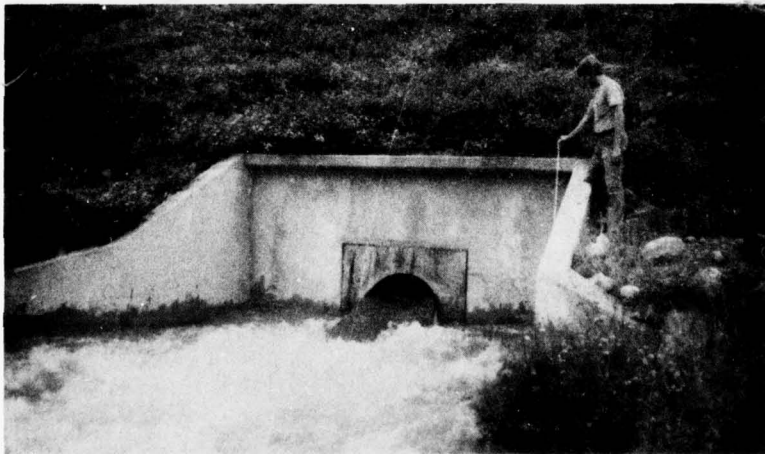
M. Outlet Works During Operation of
Slide Gate.

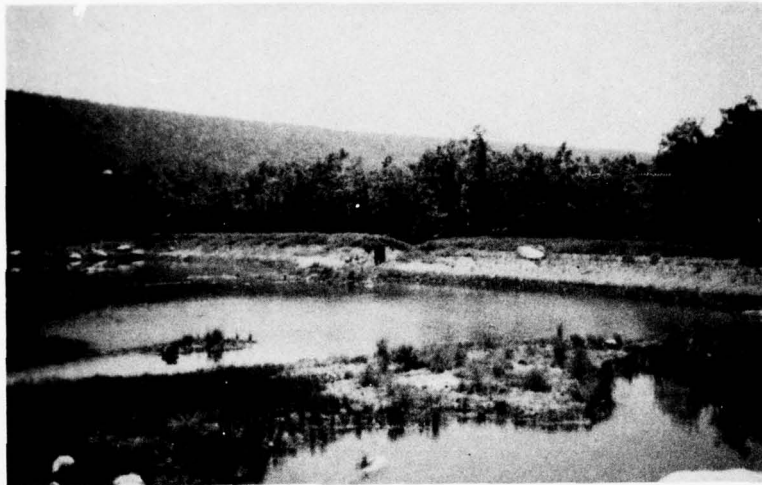
N. Lake Calumet Dam Located Upstream from
Lake Susquehanna Dam. Breached Area of
Embankment is at Center.

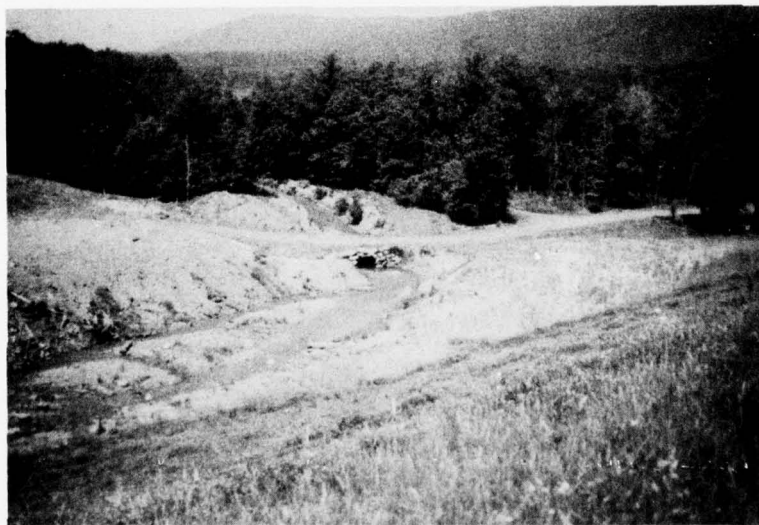
d. Downstream Channel. No conditions were observed in the downstream channel that might present significant hazard to the dam. The culvert under the access road downstream from the dam is a flow restriction. However, the position of it and the type of construction are such that it would be washed away before raising the tailwater level to the toe of the embankment. Additional discussion of downstream conditions is presented in Paragraph 5.1e.

O. Downstream Channel Area.
